NYC Hotel Intercontinental Subway Entrance

by Douglas W. Boydston

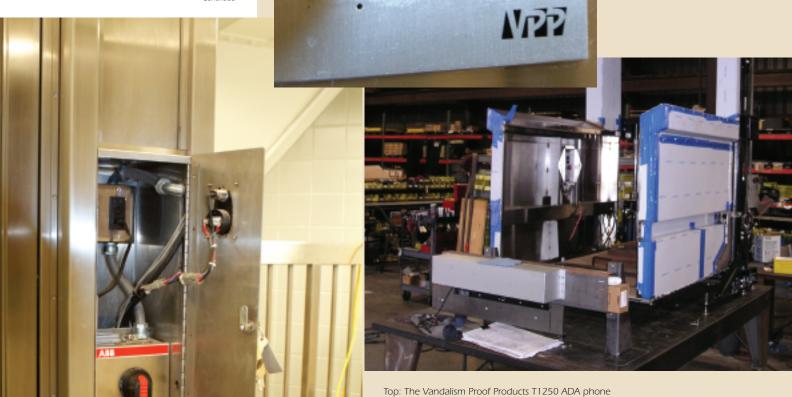
Above: Lift-U's shop, where the system was mocked up

Lift-U manufactured the elevator, which features a cantilevered, twin-screw, directdrive system that was beefed up to meet the project specifications, including a 10,000cycle test under full load. The custom stainless and glass enclosure was designed by InDetail, Inc. and built by INA Building Shop, Inc. in Brooklyn, New York. Before bringing it to the site, Handi-Lift mocked up the entire system at Lift-U's shop.

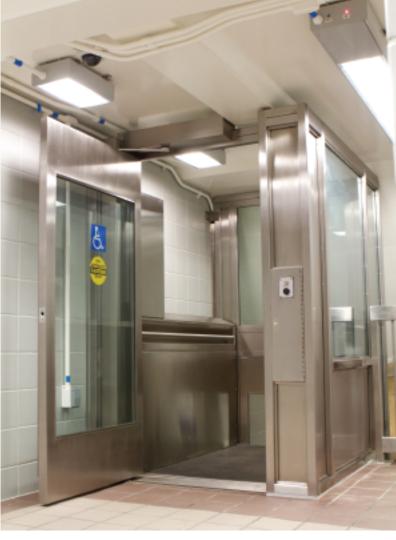
Opposite page: Side view of ramp leading to lift
